Operation TEAPOT

Project 31.2

DAMAGE TO COMMERCIAL AND INDUSTRIAL BUILDINGS
EXPOSED TO NUCLEAR EFFECTS

Bruce G. Johnston

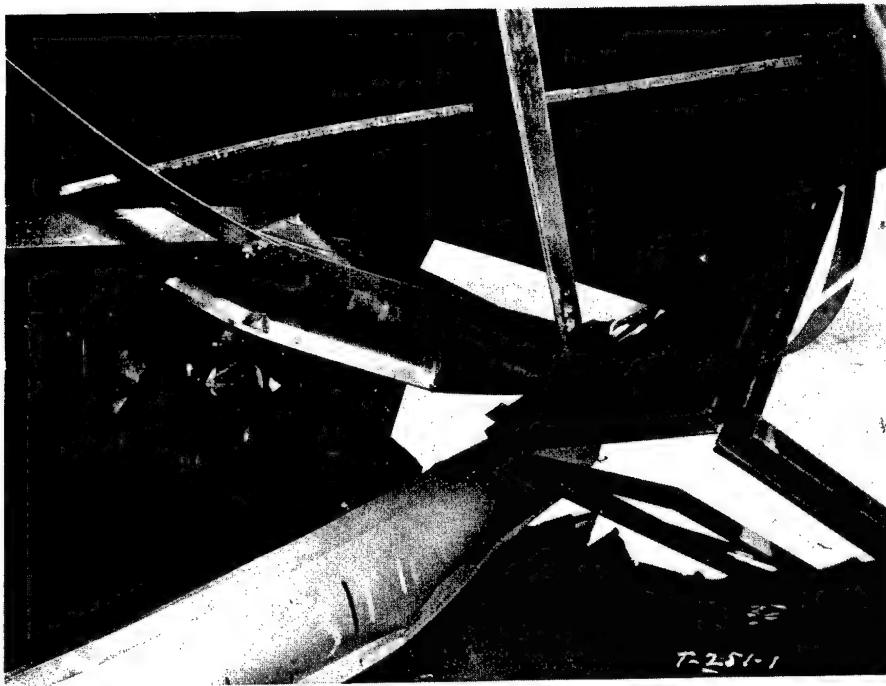
Fig. 2.44—Interior view toward northeast door frame of Armco Building 31.2-d1 after planned test.

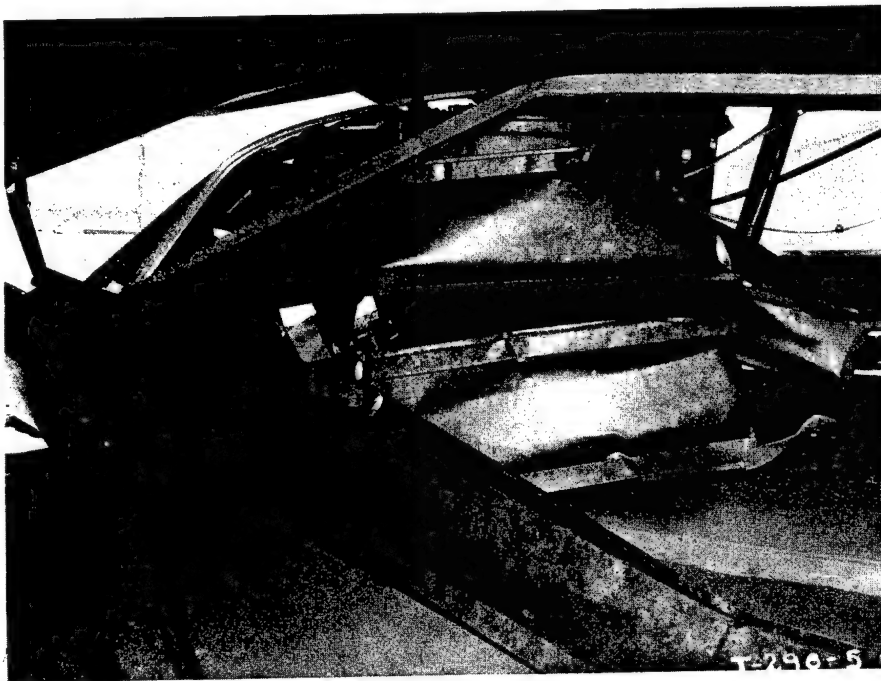
Fig. 2.45—Interior view of Armco Building 31.2-d1, showing front paneling draped around machinery after planned test.

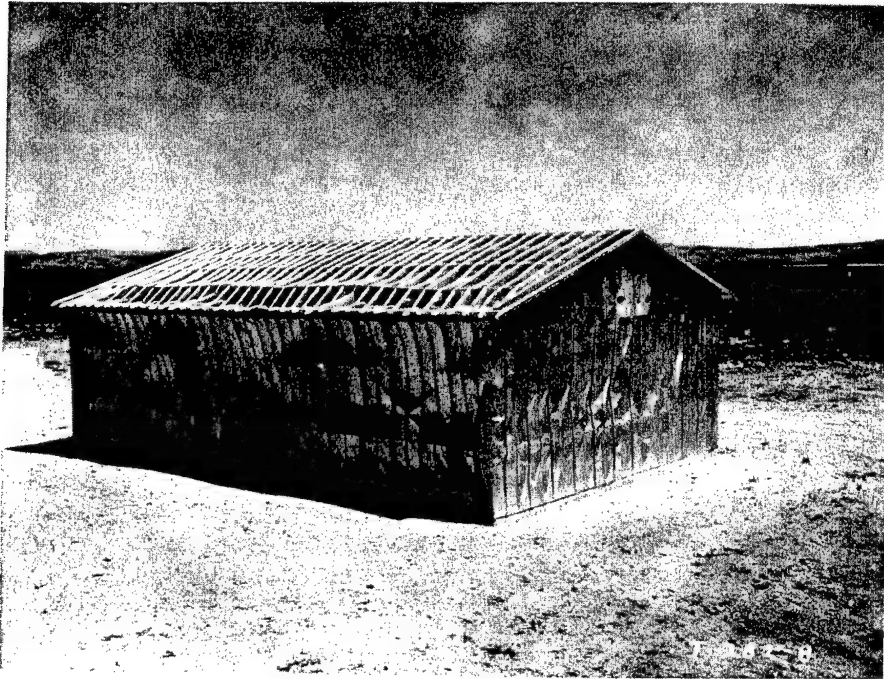
Fig. 2.46—North side and west end of Reynolds-Butler Building 31.2-a2 after planned test.

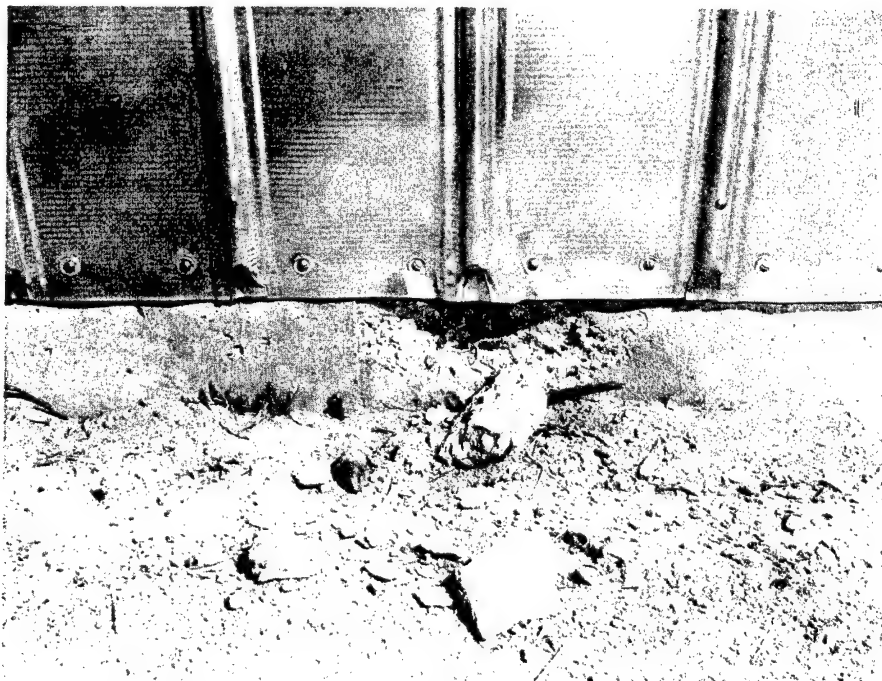
Fig. 2.47—South side of east interior column footing of Reynolds-Butler Building 31.2-a2 after planned test.

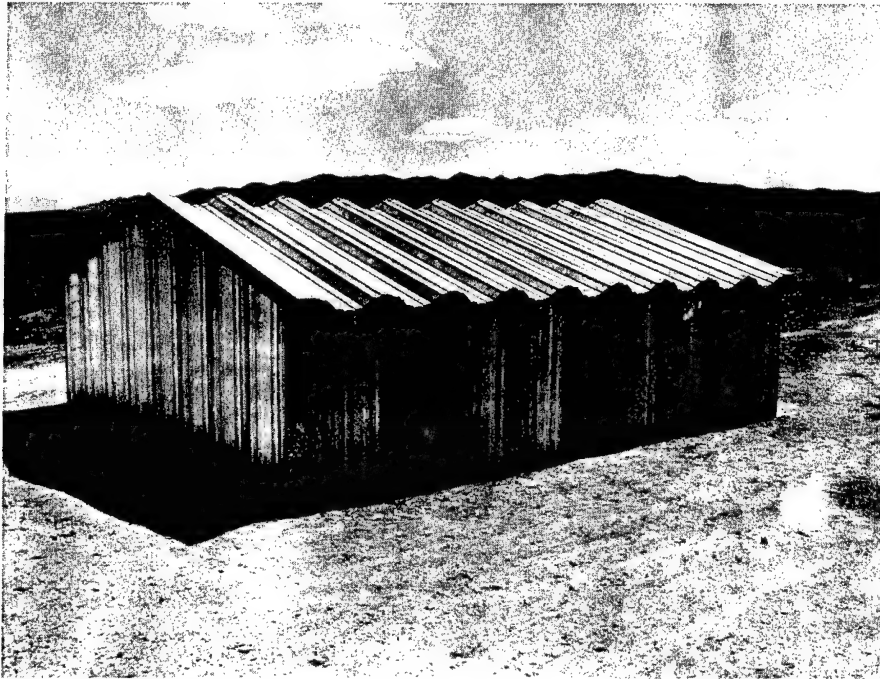
Fig. 2.50 — East end and north side of Behlen Building 31.2-b2 after planned test.

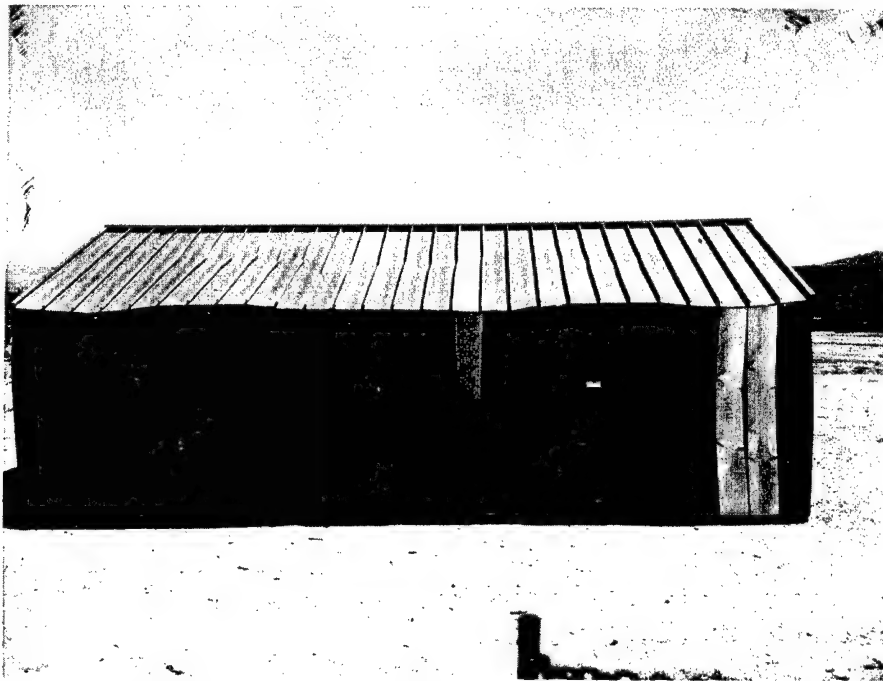
Fig. 2.51 — North side of Armco Building 31.2-d2 after planned test.
